Deterioration of Superpolished Metal Mirrors by Blue Haze.

TR-0081(6950-05)-1

1 November 1980

Interim Report

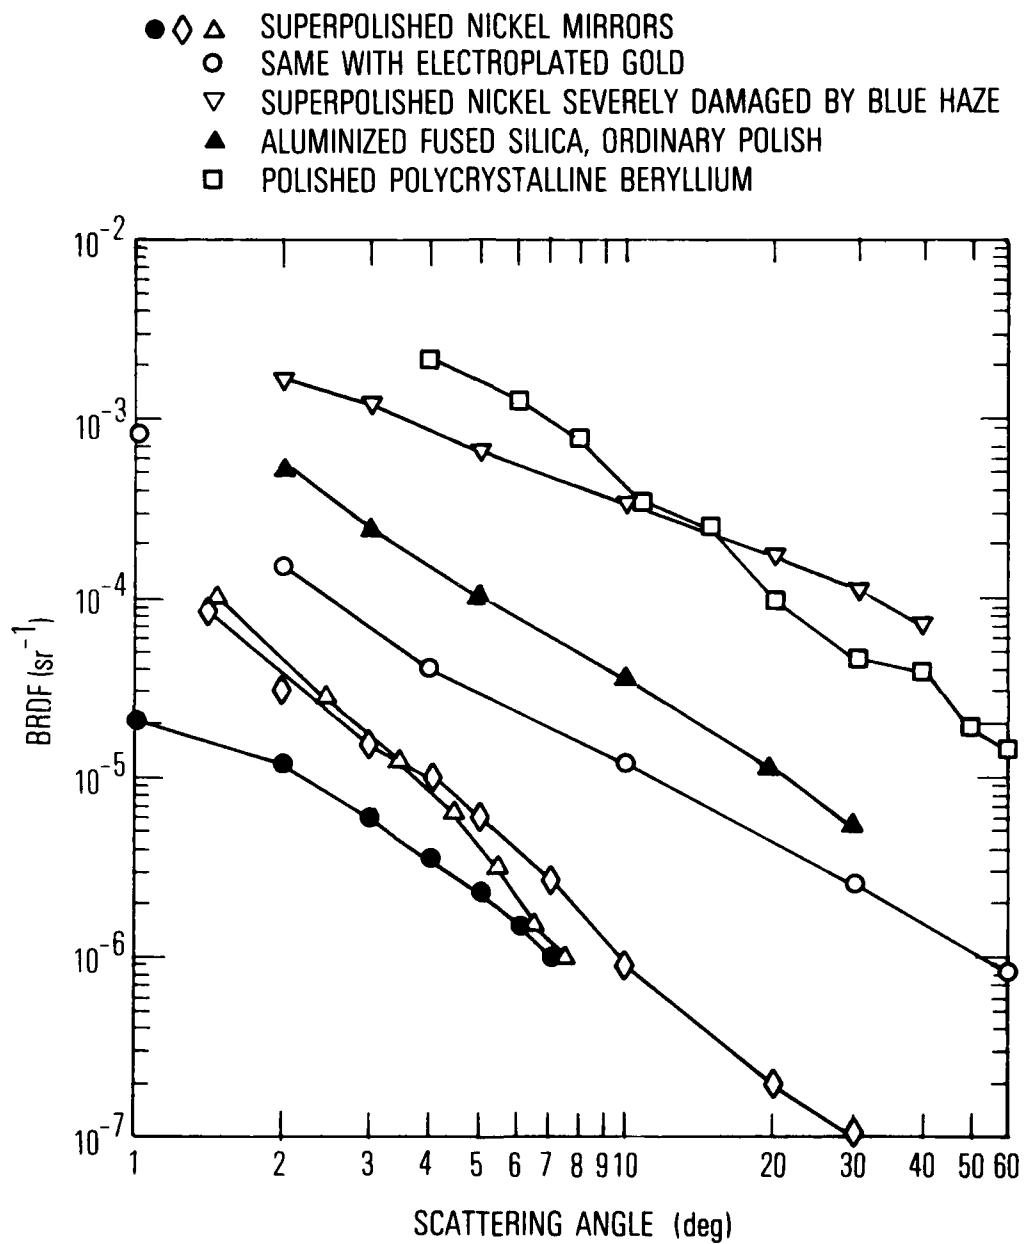
Since the invention in 1946 of electroless metal plating,[1] much has been published concerning the deposition processes and the resultant deposits, particularly nickel phosphorus alloys.[2-10] The advantages of electroless coatings over electrodeposits include uniformity of thickness, low porosity, and, consequently, better corrosion protection for steels and other metals. The use of electroless nickel coatings on lightweight beryllium and aluminum mirrors for spacecraft intensified in the late 1960s and 1970s because of the superior polish and lower scatter that could be achieved, in comparison to the substrate metals. In most of the spaceborne infrared telescopes designed for strong rejection of off-field bright sources, such as when viewing the earth's limb, so-called *superpolished electroless* nickel mirrors are used. The word "superpolished" in this context is poorly defined in terms of added performance and refers to final polishing processes that are proprietary to the vendors and which result in very-low-scatter metal mirrors. Again, "very low scatter" is poorly defined, as the surface finish of a mirror depends on many variables, including the age, plating history, and operating techniques of the electroless bath; the complexity of the mirror shape and associated tolerances, i.e., how much figuring is required; and even propitious talent and luck. Resultant mirror scatter at a wavelength of 10.6 μm can range from matching that of the smoothest fused-silica mirrors made (less than 6 Å rms roughness) to some two orders of magnitude greater scatter sometimes observed on aspherics. The bidirectional reflectance distribution function (BRDF) of some superpolished electroless nickel and two other mirrors is shown in Fig. 1.

Fig. 1.   BRDF of Several Mirrors at 10.6μm and Near Normal Incidence

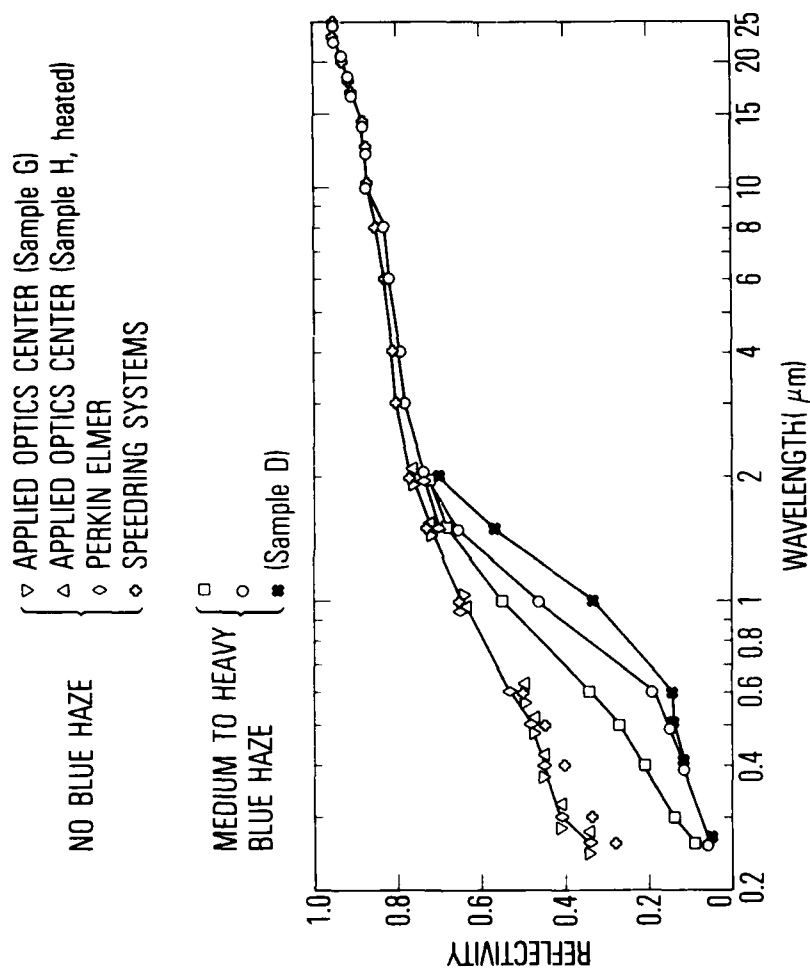
Losses in specular reflectance for severely affected and unwashed surfaces (Fig. 5) are large in the ultraviolet and visible and very slight at longer wavelengths where such mirrors are normally used.

Fig. 5. Specular Reflectance of Electroless Nickel Mirrors.
Effect of blue haze is evident.

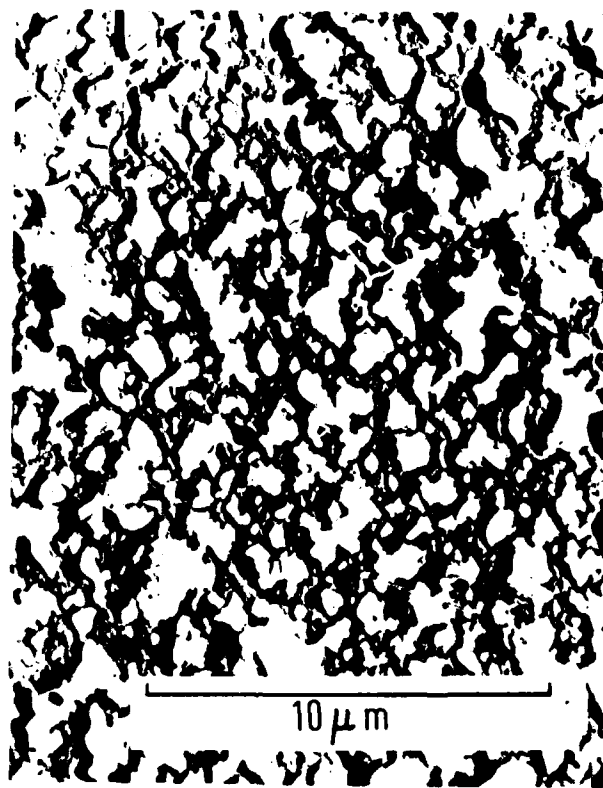
Fig. 8. Electron Micrograph of Sample A. Replica of surface is

shadowed at 80-deg angle of incidence

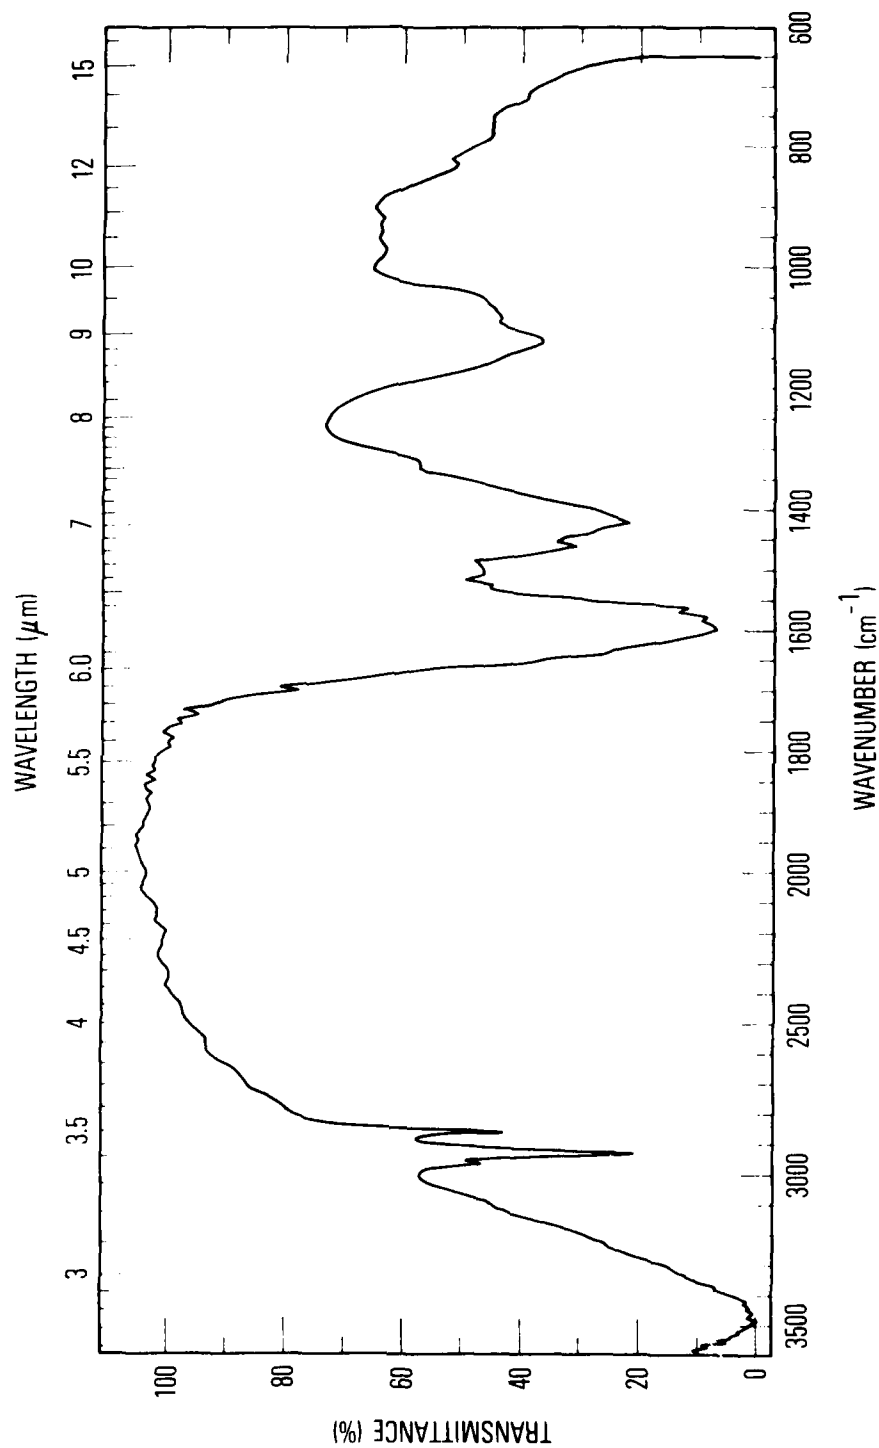
Fig. 16. Infrared Transmittance of Microquantity of Blue-Haze Scrapings

approximately 6% where the dielectric salt grows into a bump, than in nearby smooth areas with approximately 1%. The elements copper, silicon, iron, and chromium were also observed on some of the bumps. In contrast, there was no apparent correlation of nickel, phosphorus, chlorine, carbon, and oxygen surface concentrations with the location of spots or bumps on the surface. The concentrations of sodium were inconsistent and sometimes small in comparison to chlorine, indicating that the source of halogen on this sample was not necessarily sea salt, which we regard as a possible contaminant in our location.
